STATE OF TENNESSEE
DEPARTMENT OF ENVIRONMENT AND CONSERVATION
DIVISION OF WATER RESOURCES

Re: Sanitary Sewer Collection System Inspection
 City of Bartlett
 NPDES Permit No. TN0066800
 Shelby County

Compliance Inspection for Individual NPDES Permit

Facility Name: Bartlett STP #1	NPDES Tracking Number: TN0066800
Permit Effective Date: August 1, 2015	Permit Expiration Date: September 30, 2017
Date and Time of Inspection: 5/9/2017	Inspector Name: Eddy Bouzeid

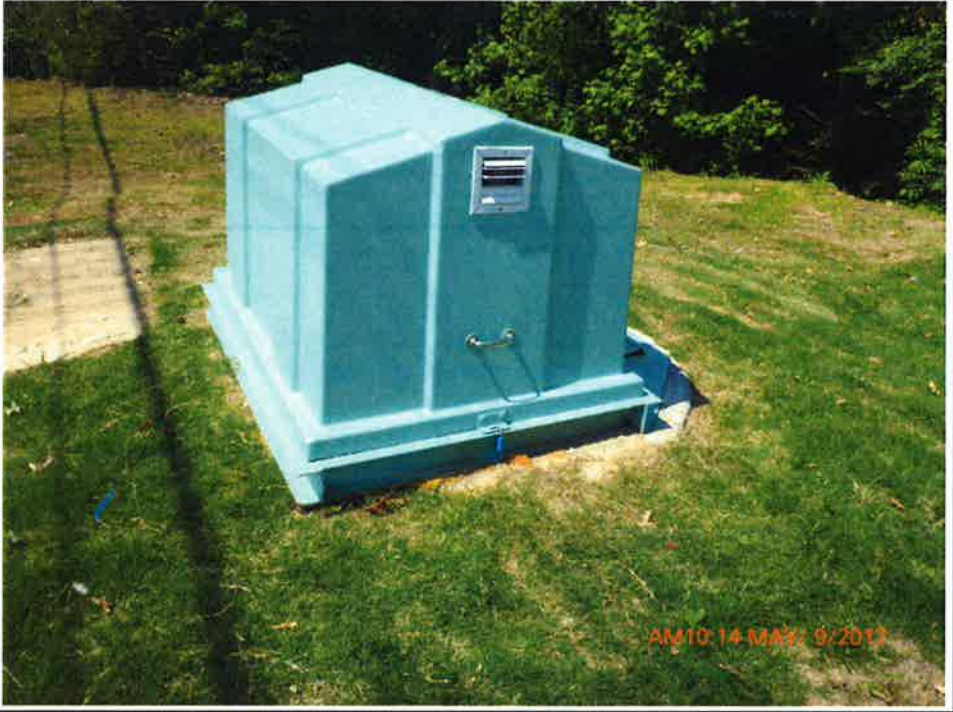
Facility Name: Bartlett STP #1		Site Location: Bartlett, Shelby County	Tracking No.: TN0066800
Photo No. 1	Date 5-9-2017

<p>AM10:14 MAZ 9/2017</p>	
Description View of the 6658 Highway 70 lift station. The lift station is padlocked for security purposes.			
Photo No. 2	Date 5-9-2017

The 6658 Highway 70 lift station was inspected during the SSCS inspection. The lift station appeared to be operating properly. According to City's records, the lift station was retrofitted in the spring of 2016. The design capacity of the lift station is 200 gpm and has two air lift pumps. The area around the lift station was not fenced, but padlocked for security purposes (photos 1 & 2). According to the log book, this station is inspected weekly.

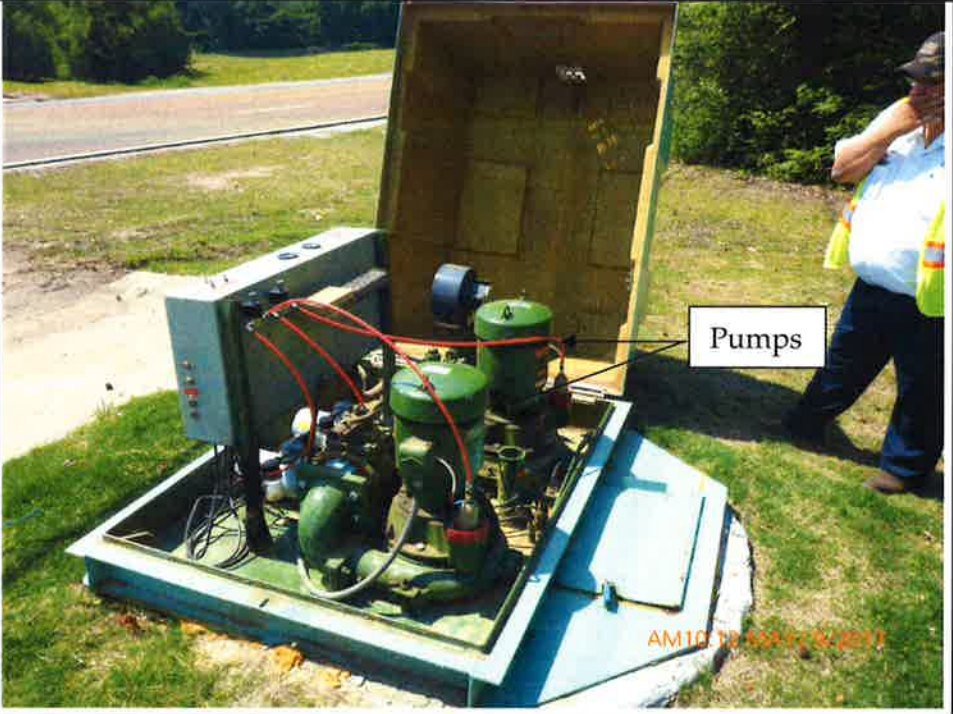
<p>AM10:19 MAZ 9/2017</p>	
Description View of the control panel and the two 200 gpm pumps inside the lift station.		<div style="position: relative; height: 100px;"> Pumps </div>

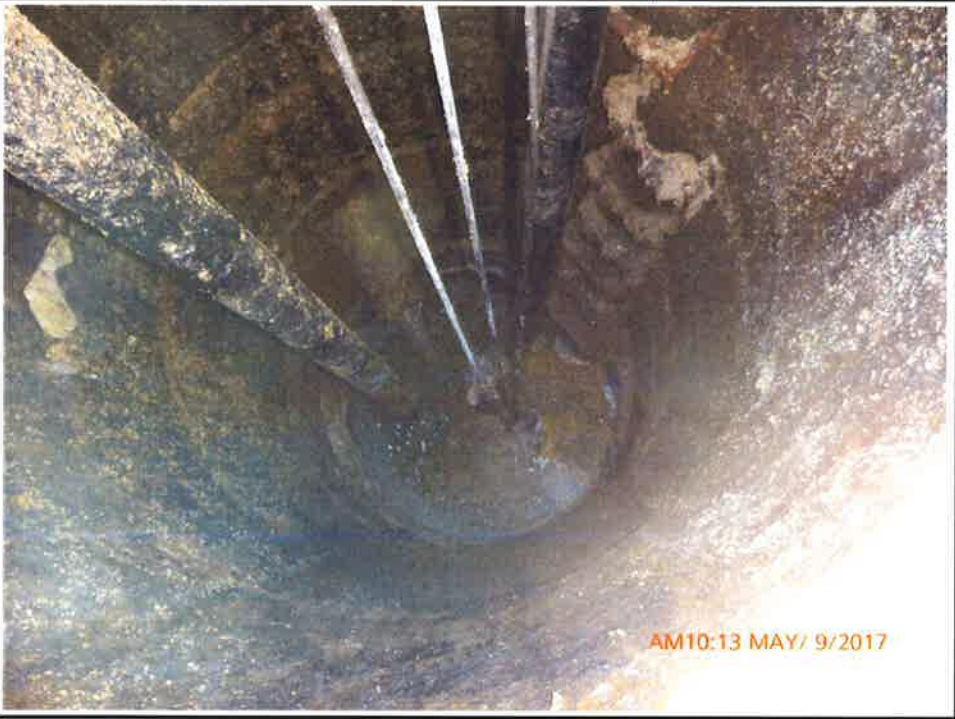
Photo No. 3	Date 5-9-2017

Description View of inside the wet well at the 6658 Highway 70 lift station. No oil sheen was observed in the wastewater.

According to Mr. Crenshaw, the 6658 Highway 70 lift station wet well and air lift pumps are maintained as needed based on the inspector's observation findings. For example, chemical degreasers are available to add at the lift station, if needed, to address grease build-up inside the wet well. At the time of the inspection, no oil sheen was observed in the wastewater inside the wet well (photo 3). The station has an hourly meter and has an audible alarm system. A back-up generator was available for emergency and as an alternate power source.

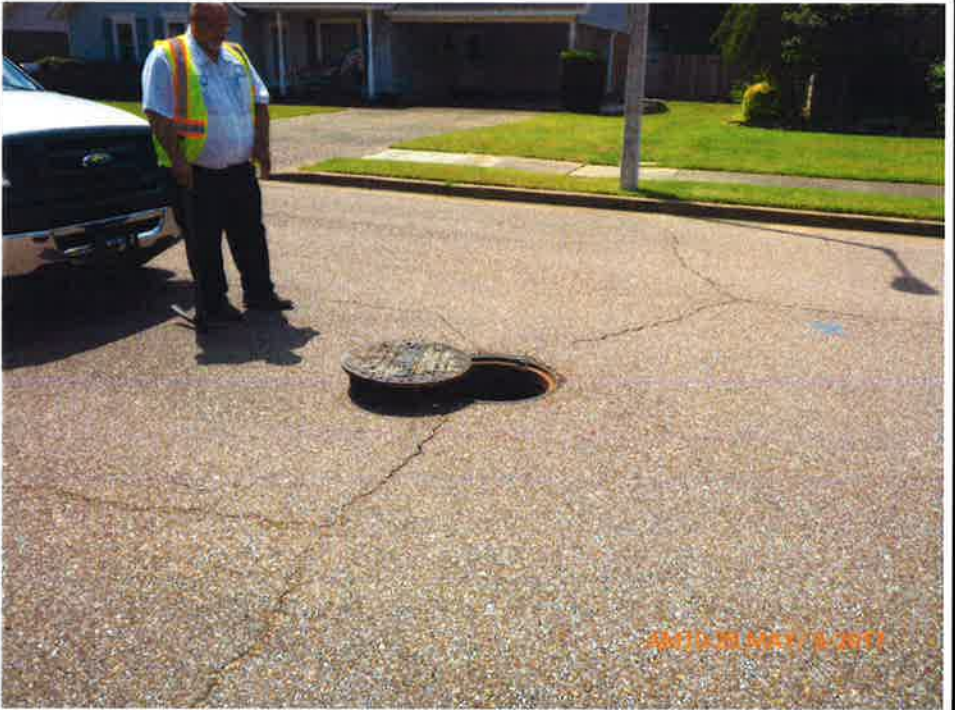
Photo No. 4	Date 5-9-2017

Description View of the manhole at 6487 Cohay Street. No stains were observed by the manhole to indicate recent overflow or I&I.

- The manhole located at 6487 Cohay is precast lined, 12 feet deep and the flow inside the manhole was normal. No problems, such as grease build up, cracks or debris, with this manhole were observed during the inspection (photo 4 & 5).
- The manhole located at 3520 Curb Stone Cove precast lined, 10 feet deep. No problems with the integrity of the manhole were observed during the inspection (photo 6 & 7). Flow inside the manhole was normal.
- The manhole located at 3588 Charlene is brick/precast lined, considered old manhole and 8 feet deep. No problems were observed during the inspection and the flow inside the manhole was normal (photo 8 & 9).

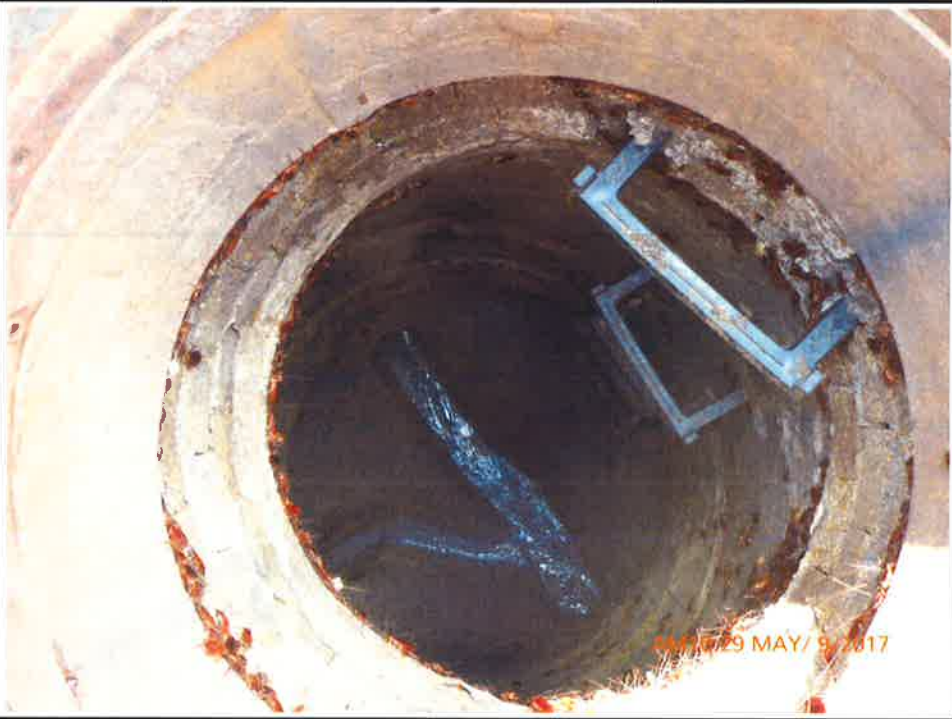
Photo No. <div style="text-align: center;">5</div>	Date <div style="text-align: center;">5-9-2017</div>	<div style="border-bottom: 1px solid black; padding-bottom: 5px;"> Description View of the inside the manhole at 6487 Cohay Street. No grease or solids built-up was observed within the manhole. </div> <div style="padding-top: 10px;">

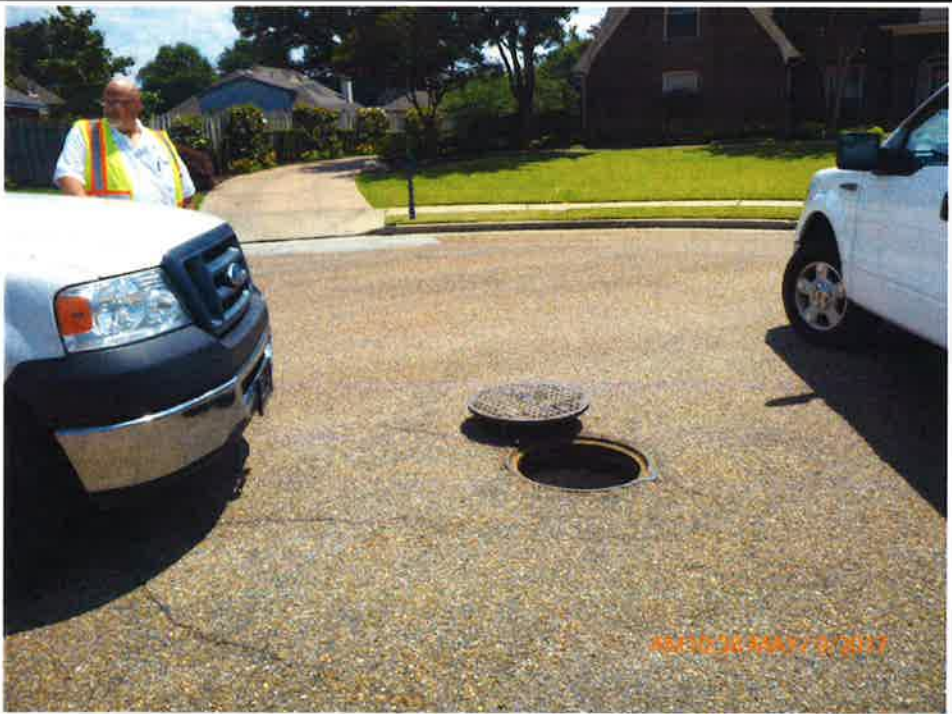
Photo No. <div style="text-align: center;">6</div>	Date <div style="text-align: center;">5-9-2017</div>	<div style="border-bottom: 1px solid black; padding-bottom: 5px;"> Description View of the manhole at 3520 Curb Stone Cove. No stains were observed by the manhole to indicate recent overflow or I&I </div> <div style="padding-top: 10px;">

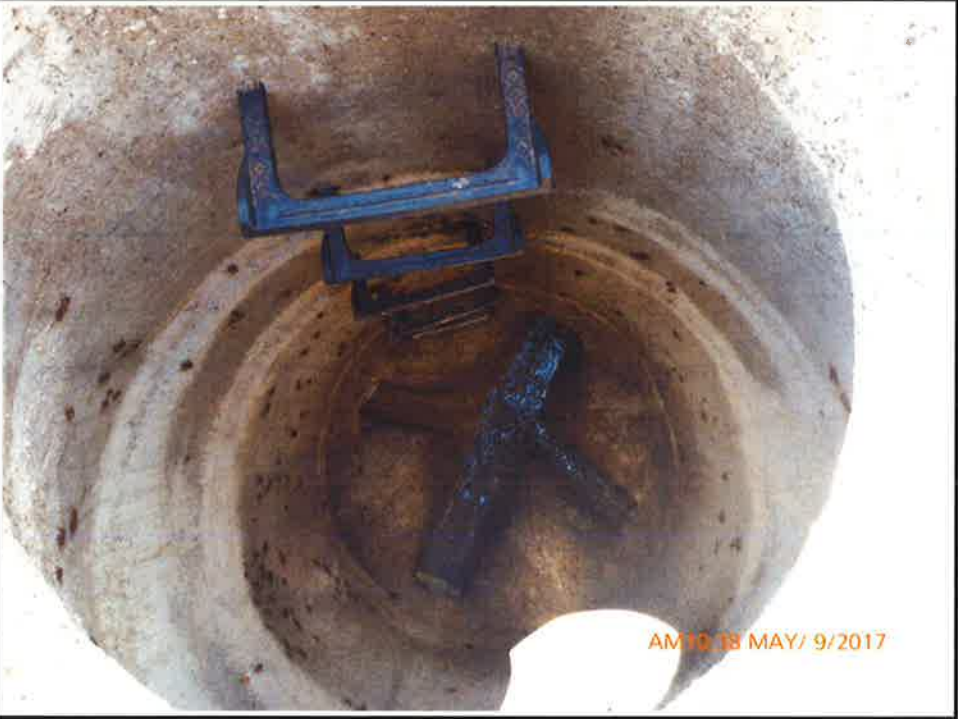
Photo No. 7	Date 5-9-2017

Description View of the inside the manhole at 3520 Curb Stone Cove. No grease or solids built-up was observed within the manhole.

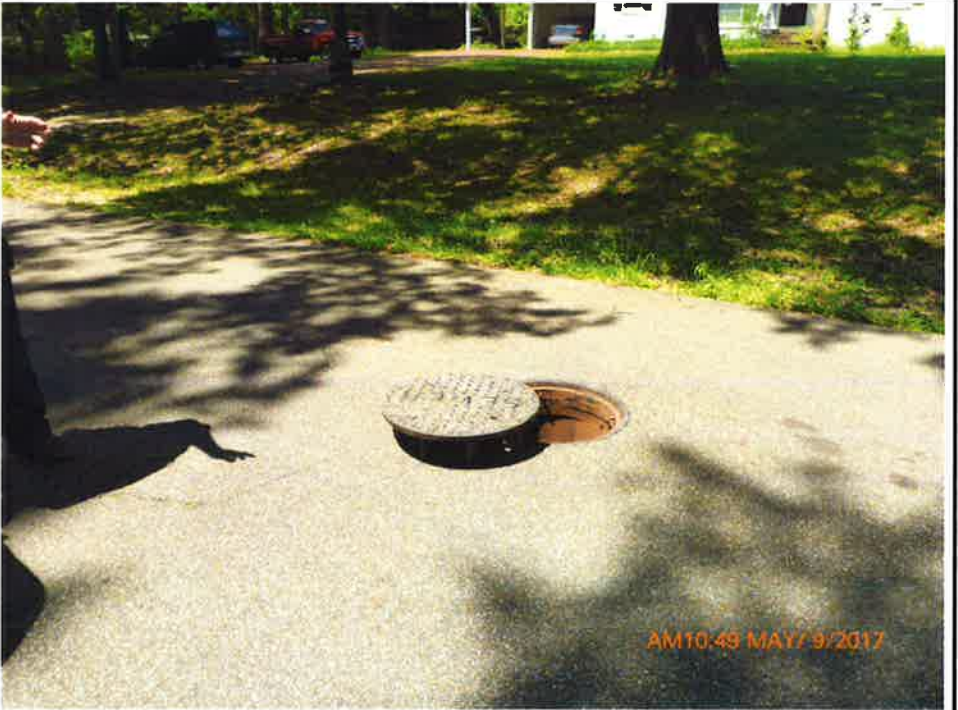
Photo No. 8	Date 5-9-2017

Description View of the manhole at 3588 Charlene. No stains were observed by the manhole to indicate recent overflow or I&I

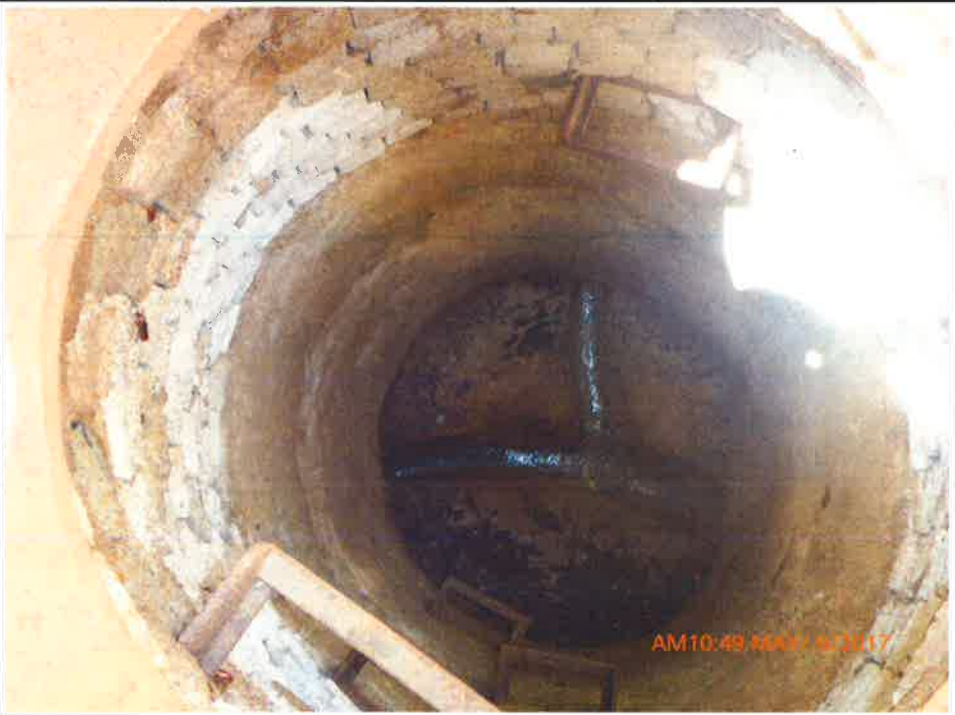
Description View of the inside the manhole at Charlene. No grease or solids built-up was observed within the manhole.
